PHASE I AND II GEO-ENVIRONMENTAL  
GROUND INVESTIGATION

21<sup>ST</sup> MAY 2019

Site:	[REDACTED]
Title:	PHASE I AND PHASE II GEO-ENVIRONMENTAL GROUND INVESTIGATION
Client:	[REDACTED]
Date:	21 <sup>st</sup> MAY 2019
Reference:	[REDACTED]
Version:	V1.0
Prepared by:

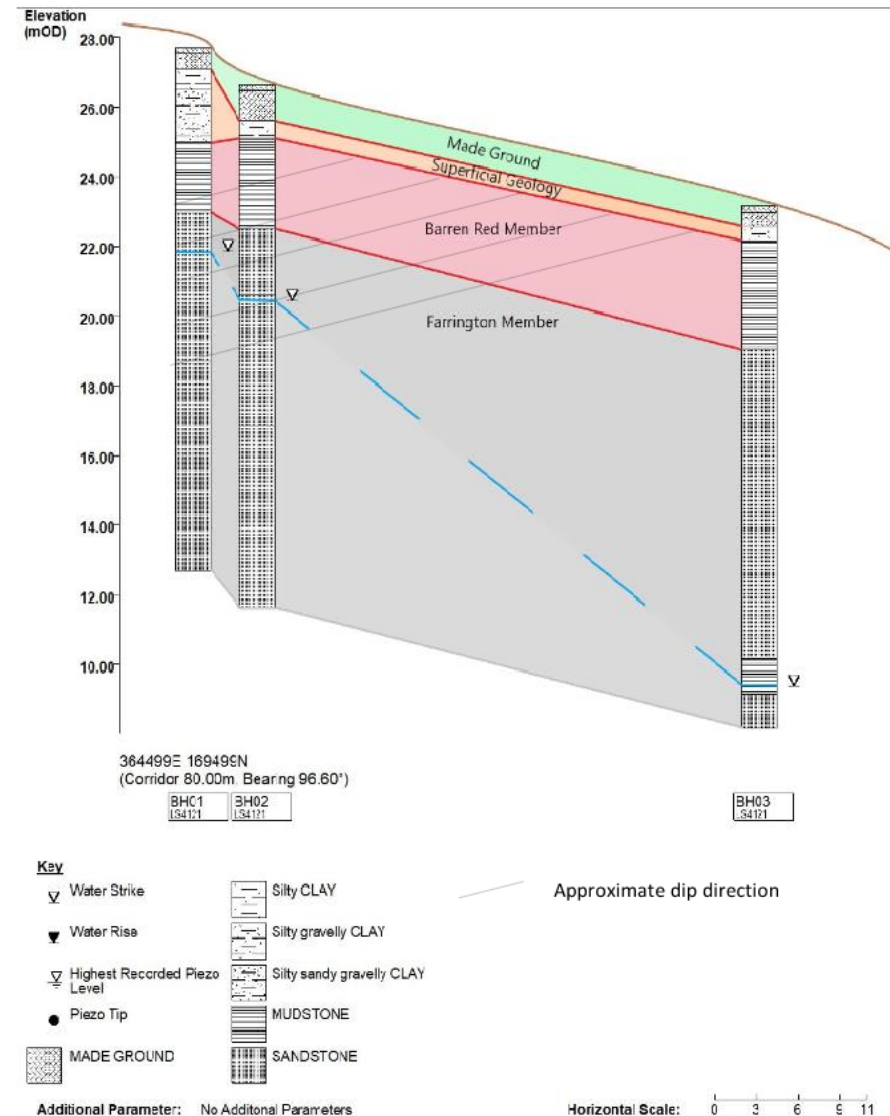
This deep groundwater on site is modelled, from the monitoring wells, to be flowing in an easterly direction. Indicating that any product entering the groundwater at the source of the spill may be directed away from BH01, under the existing buildings, and towards surface water features to the east.

The presence of TPH product within BH01 indicates that the product has either travelled through the ground (against groundwater flow) or has found another pathway. Local bedding orientations with the Barren Red and Farrington Members support the theory that the product may have travelled through the strata to the groundwater at BH01. The geological cross-section below models the potential for groundwater flow along dipping bedding planes.
